Manhole Inspection Summary

Manhole # S17KK_004MH

Insp Date: **3/11/09 1:05 PM**

Location Address: **2048 BENTALOU ST**

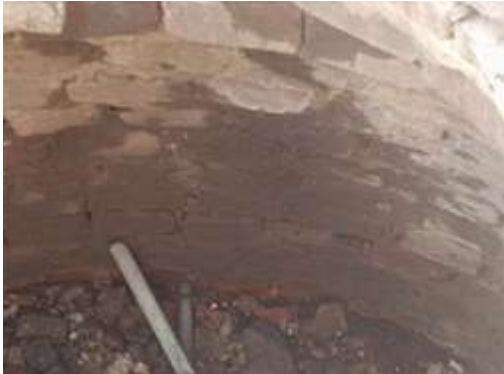
Defect 3

Infiltration: ☐ None ☐ Joint ☐ Cracks ☐ Mortar ☐ Roots ☒ **Wall**

debris

INFILTRATION OF CORBEL

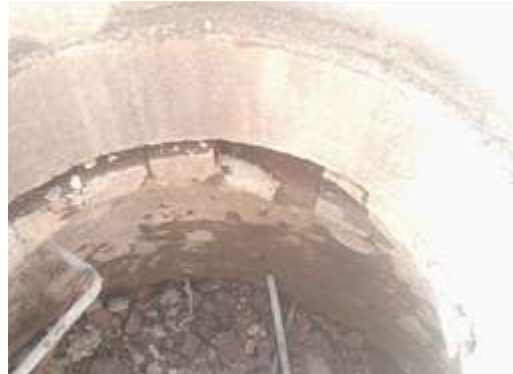
Defect 2

Condition: ☐ Sound ☐ Cracked ☐ Root Intrusion ☐ Loose Brick ☒ **Deteriorated**

DETERIORATION OF CHIMNEY

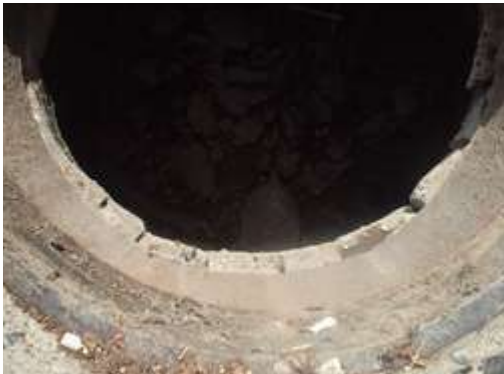
Defect 1

Frame Offset: **1** (in.) Condition: ☒ Sound ☐ Cracked ☐ Leaks

Condition: ☐ Sound ☐ Cracked ☐ Root Intrusion ☐ Deteriorated ☐ Leaks ☒ **Debris**

FRAME OFFSET AND DEBRIS IN
CHANNEL AND BENCH

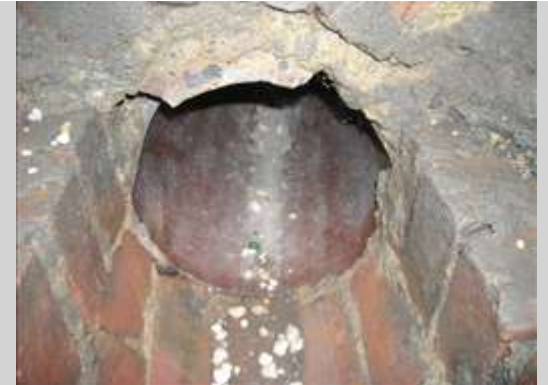
12 O'Clock Outflow

8 in. Circular Gravity Sewer
Pipe Out @ 12 O'Clock

Pipe Height: **7.2** (in.) Rod and Bar (Angled)
Pipe Material: **Clay** ☐ Pipe Lined
Invert Depth: **4.24** (ft.) Flow Characteristics: **None**
Deposits: ☐ None ☐ Mud ☐ Sludge ☒ **Debris** ☐ Grease
Silt Depth: **4** (in.) Deposits Extent: **Medium**
Infiltration: **None** Pipe Seal Cond: **Broken**

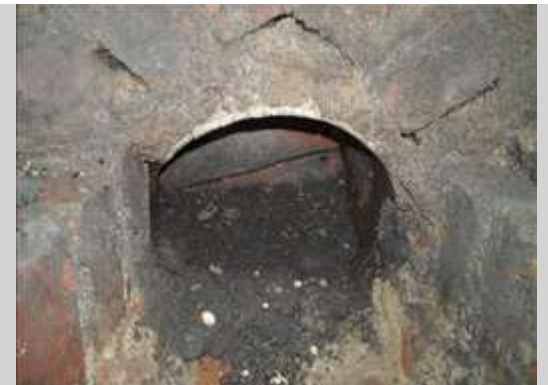
3 O'Clock Inflow

6 in. Circular Gravity Sewer
Pipe In @ 3 O'Clock

debris

Pipe Height: **6** (in.) Rod and Bar (Angled)
Pipe Material: **Clay** ☐ Pipe Lined
Invert Depth: **3.87** (ft.) Flow Characteristics: **None**
Deposits: ☐ None ☐ Mud ☐ Sludge ☒ **Debris** ☐ Grease
Silt Depth: **5** (in.) Deposits Extent: **Heavy**
Infiltration: **None** Pipe Seal Cond: **Broken**

Connects To: **Stub connection / abandoned**
